### CUSTOMER PRODUCT SAFETY NOTICE & REMEDIATION ADVICE

Easy Access Attic Ladder— OX-AAL27 or OX-TAL28

#### Sold before August 2017

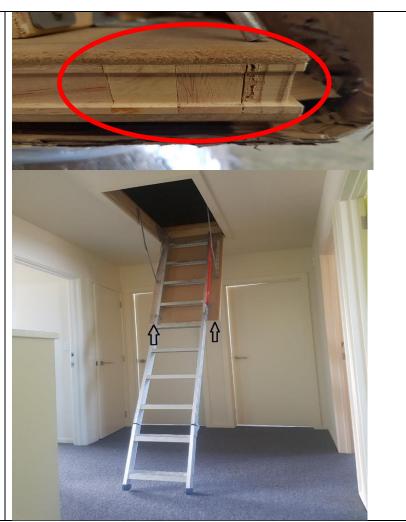
## Step 1 Lower the base of the timber attic ladder and check that the backing timber in the frame is

laminated.

The arrows in the second photo indicate where to inspect the ladder base frame for laminated timber.

NB: If solid timber is used no remediation is required.

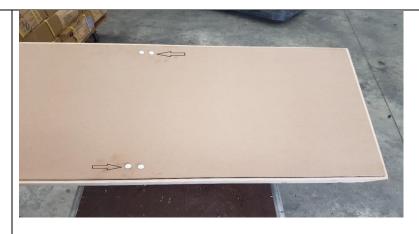
The photo adjacent shows the caps on an unpainted base.

The 'snap caps' will blend in well with typical ceiling colour. The circles in the second photo show their approximate location

### Step 5: Insert the 'snap cap' covers over the head of each bolt.
